Pit Snipe Property inspection

Property address: **123 fairytale lane Pittsburgh PA 15221-3523**

Inspection date: **Sunday, July 21, 2024**

sample report

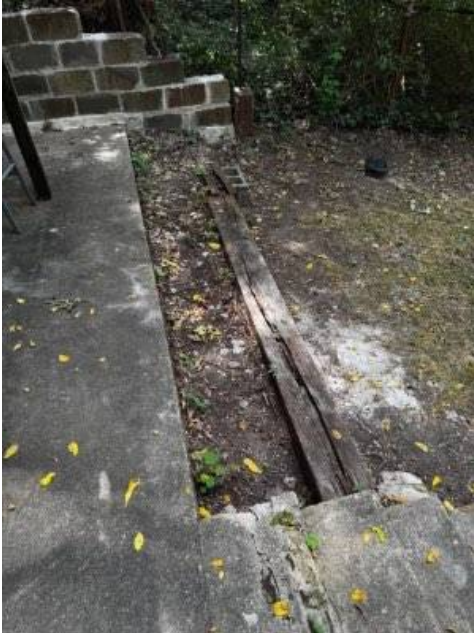
Railroad tie leading from back porch is rotted. This is will allow for injury are worst. Recommend a reputable contractor.

Photo 2-1 backyard retaining wall

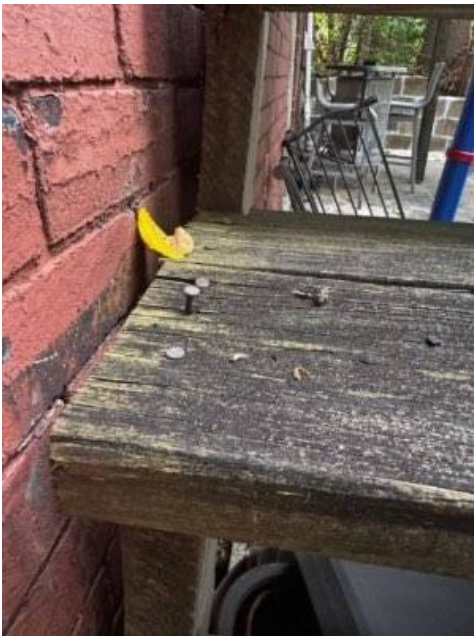
Nails popping and need resealed on backyard steps. This is a trip hazard are worst. Recommend power washing and paint or seal steps. Recommend a reputable contractor.

Photo 3-1 exposed nails backyard stairs

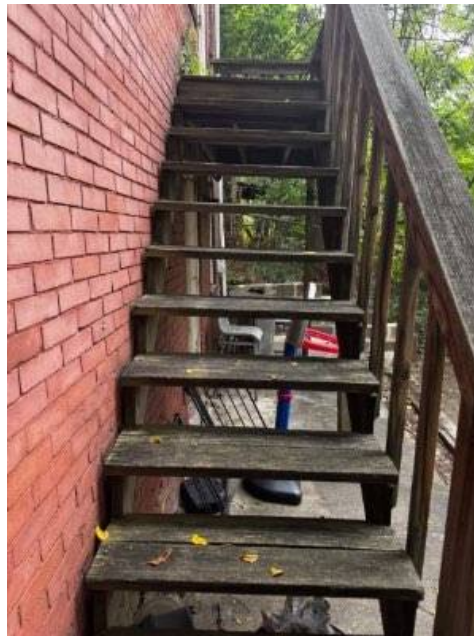
Photo 3-2 steps need powerwash and resealed

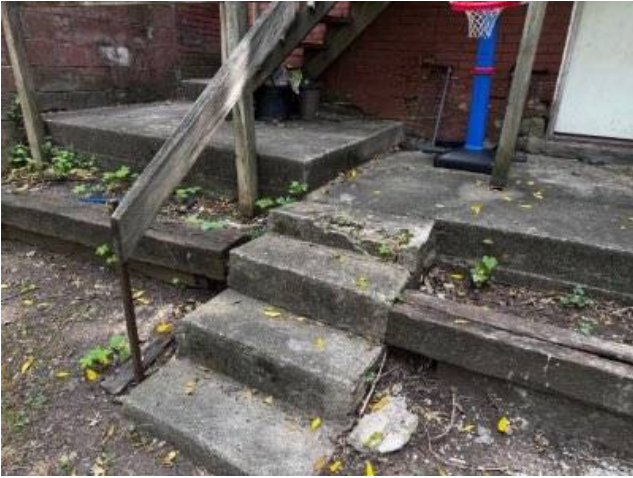
Photo 4-1

Detoriated concrete steps and missing baluster and handrails throughout the back porch. This is a fall hazard. Recommend a reputable contractor.

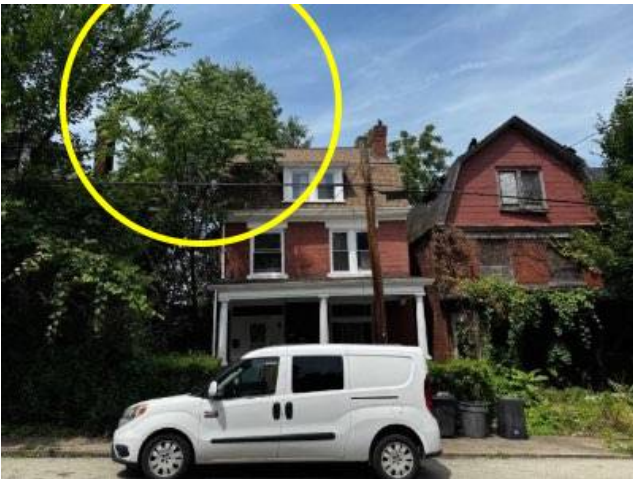
Tree branches too close to house. This will allow for pest infestation. Recommend trimming back 2 to 3 feet. Recommend a reputable contractor.

Photo 5-1 Tree touching left side of house

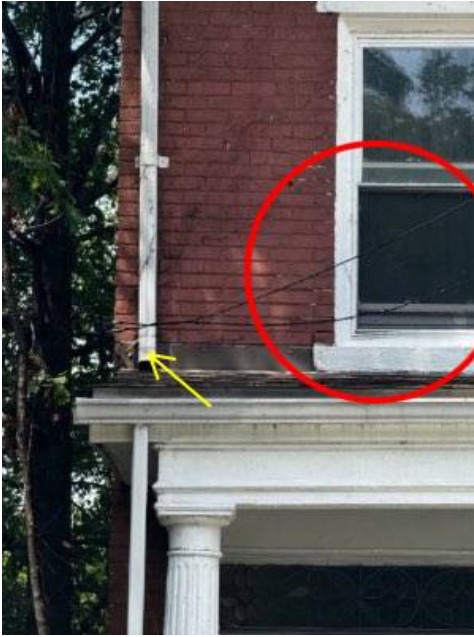
Downspout extension missing above front porch. This will allow for water penetration to the foundation. This will allow premature aging of the shingles. Recommend a reputable contractor.

Photo 6-1 Missing extension on downspout

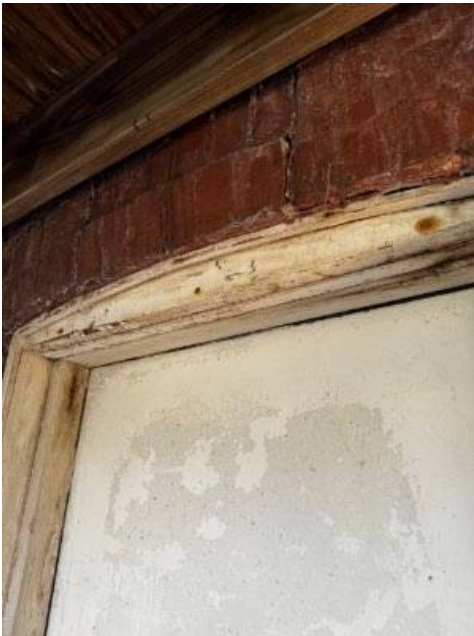
Mortar has fell out in bricks above basement door. Recommend filling in with concrete coaking. Continue to monitor. Recommend a reputable contractor.

Photo 7-1 above back door basement

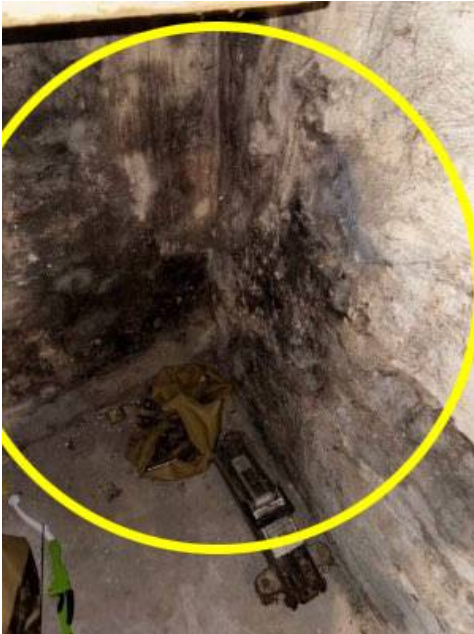
There is Efflorescence (mineral salts) on front foundation wall. Recommend a reputable waterproofing contractor.

Photo 8-1 front wall right corner efflorescence

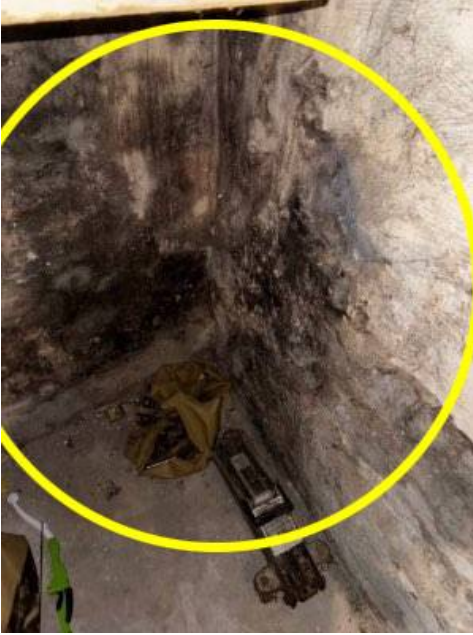
There is probable mold on front foundation wall. Recommend a reputable certified mold tester.

Photo 9-1 front wall right corner efflorescence

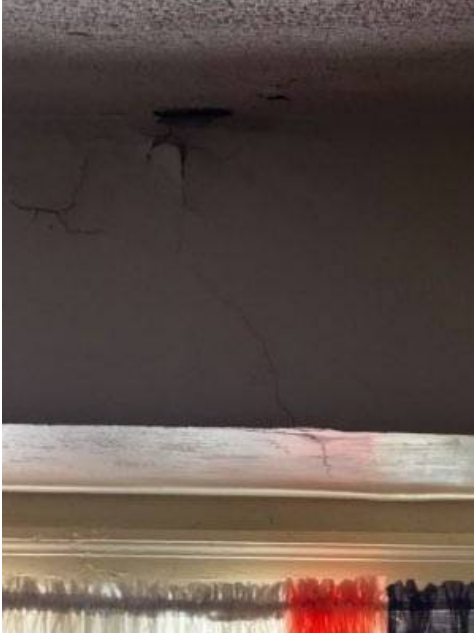
Previous water damage was discovered in room in attic roof was replaced in 2024. Continue to monitor.

Photo 11-1 roof was replaced in 2024

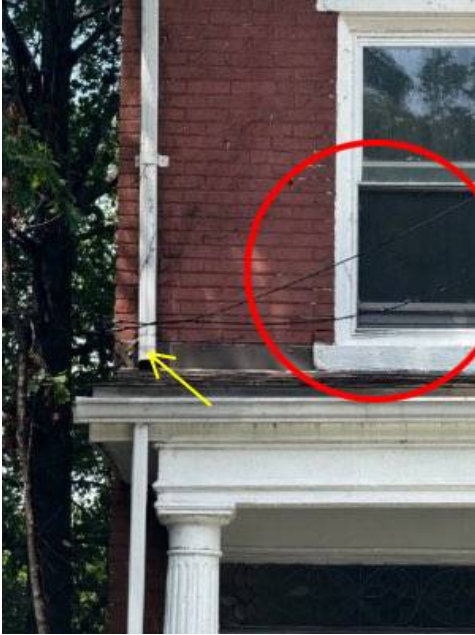
Electrical power lines are too close to bedroom window above front porch. This is a shock hazard at worst. Recommend a reputable licensed electrical contractor.

Photo 12-1 Missing extension on downspout

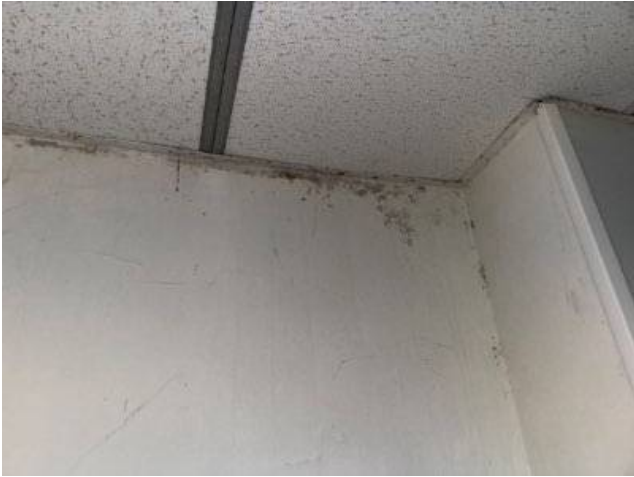
Probable mold in bathroom. Recommend a reputable certified mold tester.

Photo 15-1 probable mold

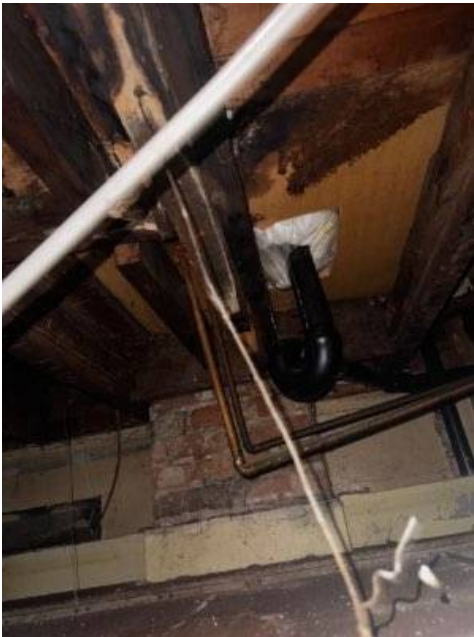
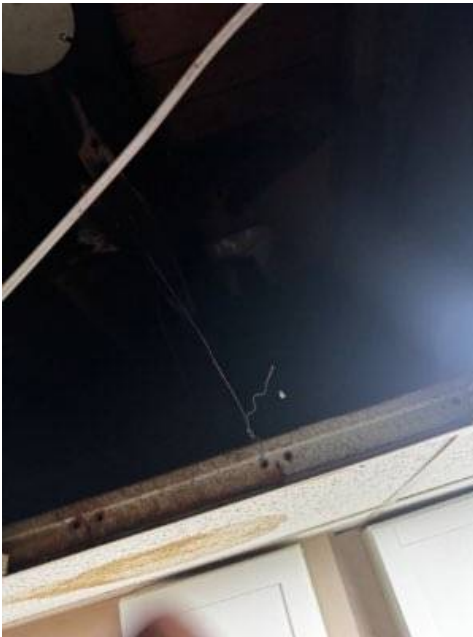
Shower drain appears to be leaking. Recommend a reputable licensed plumbing contractor.

Photo 16-1 ceiling above kitchen

Photo 16-2 ceiling above kitchen

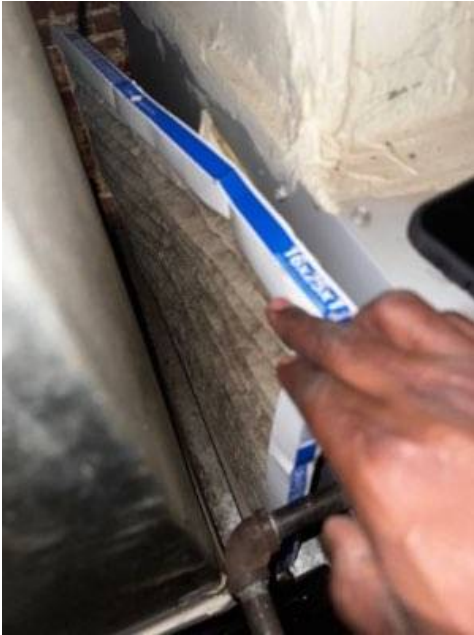
Dirty filter. Recommend replacing filter every 30 days and having unit cleaned every 6 months are during season change. Recommend reputable hvac contractor.

Photo 19-1 dirty filter need replace

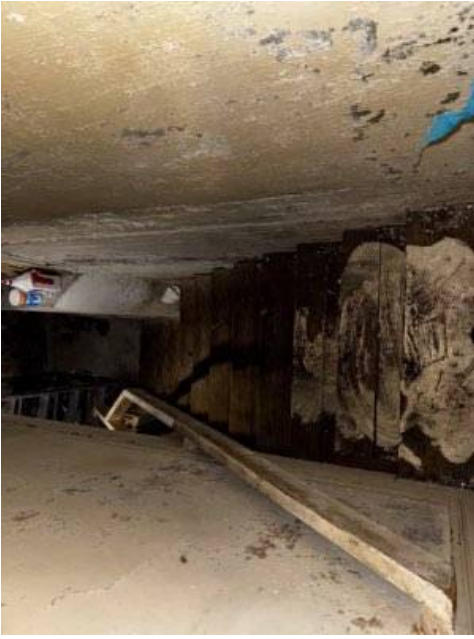
Photo 21-1

The right side of steps leading to basement missing handrails and balusters. This is a fall hazard. Recommend a reputable contractor.

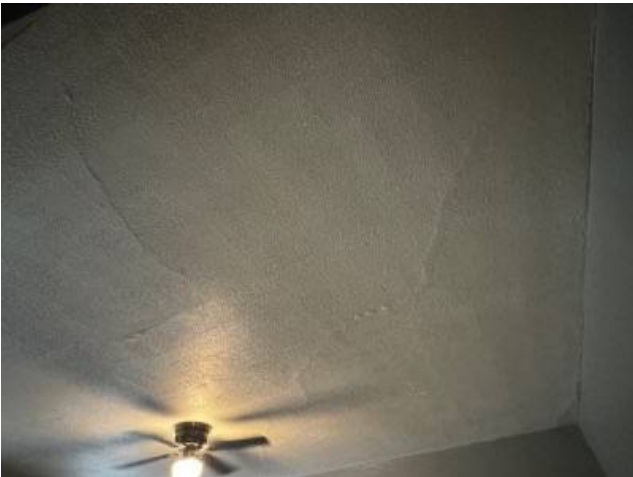
22) 🛠️ Settlement cracks in dining room and living room ceiling Continue to monitor. Recommend replastering.

Photo 22-1 Dining room ceiling

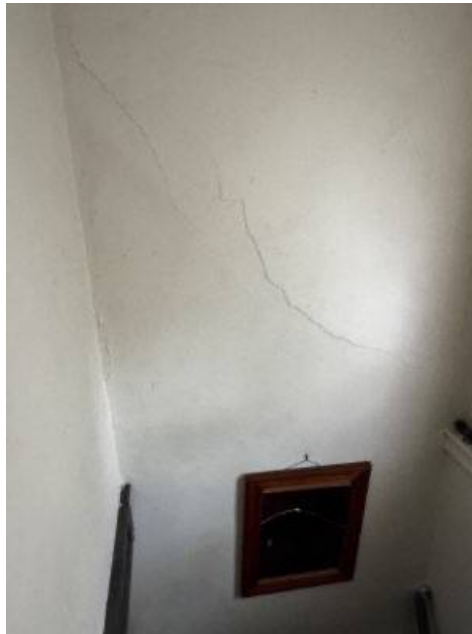
Photo 22-2 Living room ceiling
